# Manhole Inspection Summary

Manhole # S15C1\_022MH

Insp Date: **6/30/08 10:46 AM**

**Location** Address: **2916 georgetown rd**

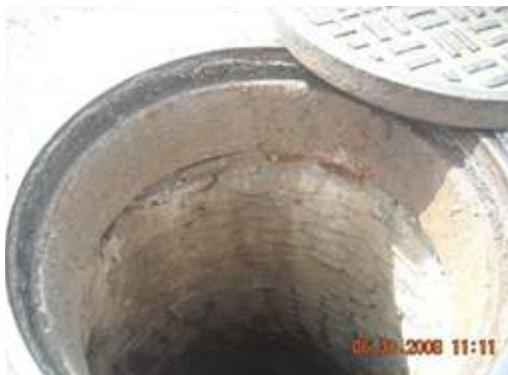
Misc

Subject To Ponding: **Sheeting**

inflow evidence from sheeting

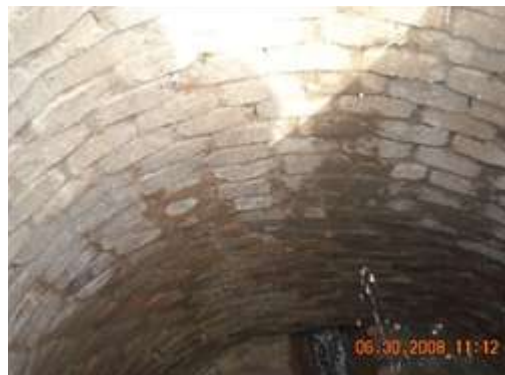
Defect 4

Infiltration: ☐ None ☒ **Joint** ☐ Cracks ☐ Mortar ☐ Roots ☐ Wall

infiltration @ barrel wall

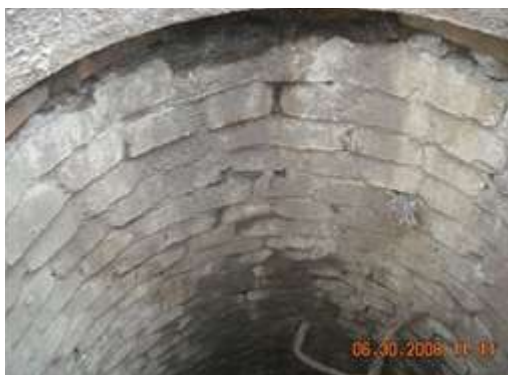
Defect 3

Infiltration: ☐ None ☒ **Joint** ☐ Cracks ☐ Mortar ☐ Roots ☐ Wall

infiltration @ chimney/frame joint

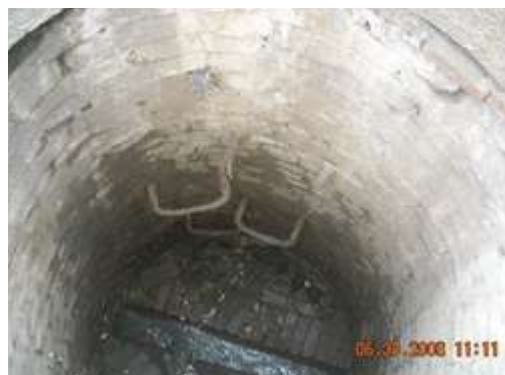
Defect 1

Count: **3** Missing: **2** ☒ **Corroded**

corroded & missing steps

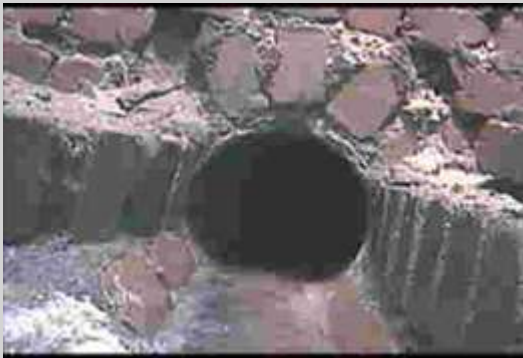
12 O'Clock Outflow

8 in. Circular Gravity Sewer  
Pipe Out @ 12 O'Clock

Pipe Height: **8.4** (in.) Rod and Bar (Angled)  
Pipe Material: **Clay** ☐ Pipe Lined  
Invert Depth: **9.18** (ft.) Flow Characteristics: **Slow**  
Deposits: ☒ None ☐ Mud ☐ Sludge ☐ Debris ☐ Grease  
Silt Depth: **0** (in.) Deposits Extent:  
Infiltration: **None** Pipe Seal Cond: **Sound**

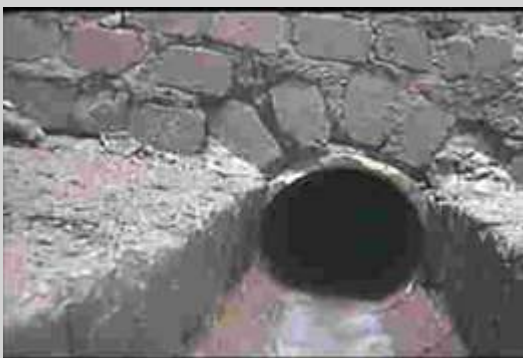
6 O'Clock Inflow

8 in. Circular Gravity Sewer  
Pipe In @ 6 O'Clock

Pipe Height: **8.4** (in.) Rod and Bar (Angled)  
Pipe Material: **Clay** ☐ Pipe Lined  
Invert Depth: **9.10** (ft.) Flow Characteristics: **Slow**  
Deposits: ☒ None ☐ Mud ☐ Sludge ☐ Debris ☐ Grease  
Silt Depth: **0** (in.) Deposits Extent:  
Infiltration: **None** Pipe Seal Cond: **Cracked**

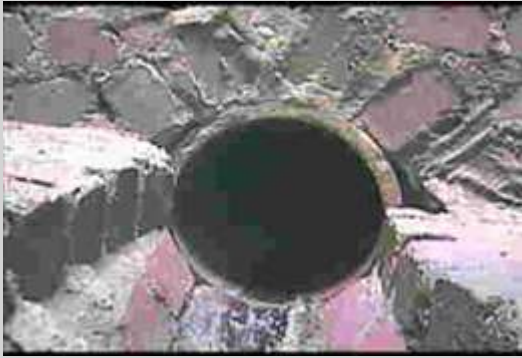
9 O'Clock Inflow

8 in. Circular Gravity Sewer

Pipe In @ 9 O'Clock

Infiltration: **None** Pipe Seal Cond: **Sound**
